AIRCRAFT GROUND-FLOTATION INVESTIGATION

PART XIII. DATA REPORT ON TEST SECTION 13

U. S. ARMY ENGINEER WATERWAYS EXPERIMENT STATION

TECHNICAL REPORT AFFDL-TR-66-43, PART XIII

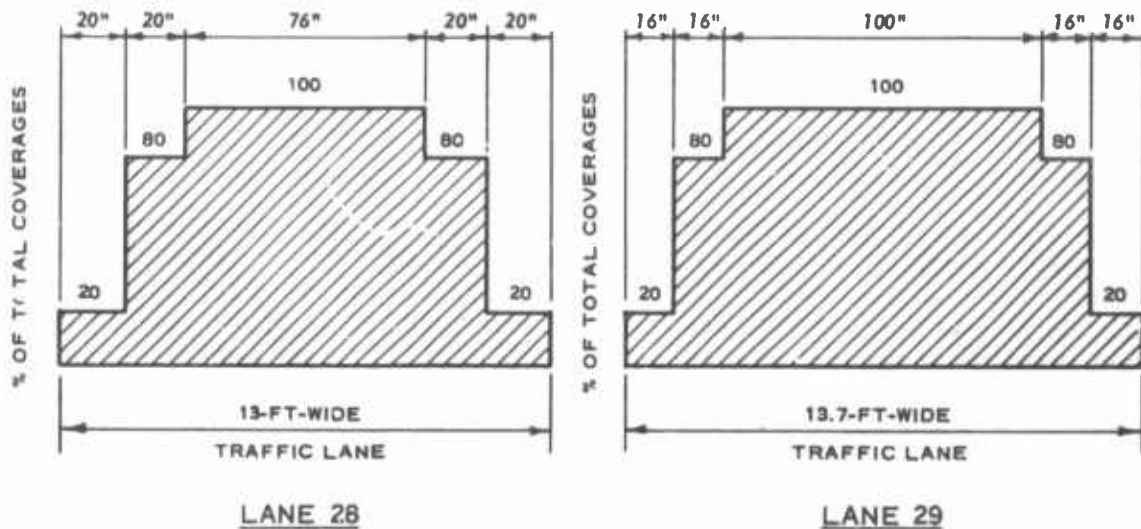
Figure 1. Traffic distribution patterns on Test Section 13

Traffic was applied to the test lanes in a nonuniform pattern with intensity of traffic being varied within each lane to produce three zones of approximately 100, 80, and 20 percent traffic coverage. Traffic so distributed within a traffic lane simulates as nearly as possible the bell-shaped traffic distribution curve which results from the wander of aircraft from the lane center line. The coverage levels referred to in the tables and text herein are the total number of coverages applied to the 100 percent coverage zone. The corresponding number of coverages applied to the outer traffic zones is proportional to the percentage factor for the respective zones as shown in figure 1. Typically, the lane widths used were not exact multiples of the tracking tire widths and spacings so that it was necessary to determine a coverage factor for each lane to compensate for overlap or gaps in the traffic pattern.

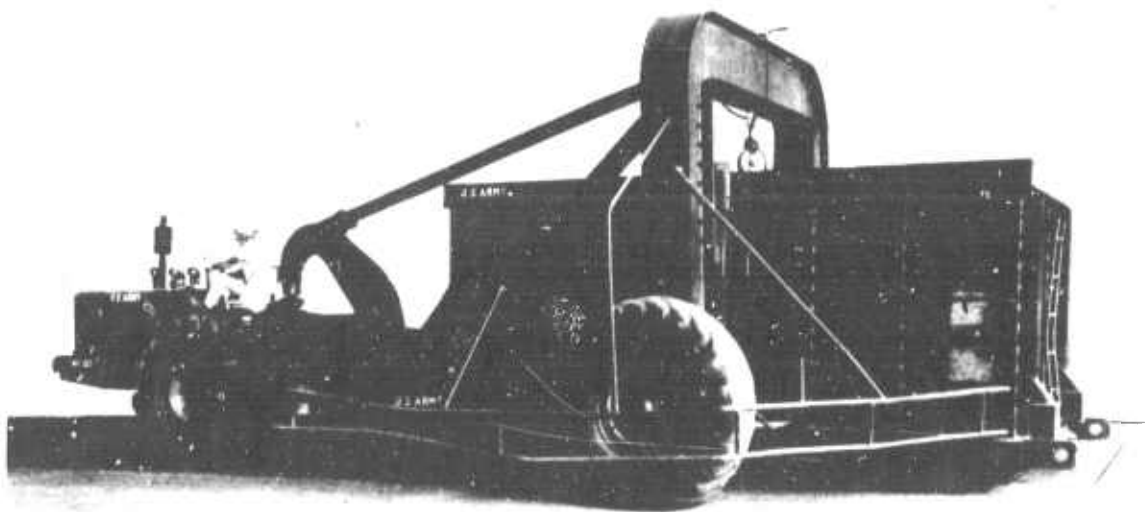
Figure 2. Load vehicle

The load vehicle used for trafficking test lanes in Section 13 is shown in figure 2. Load cart construction, details of linkage between the load compartment and prime mover, and method of applying load are explained in Part I. For trafficking lanes 28 and 29, a twin-wheel assembly was used with a 70,000-lb test load. The assembly consisted of two 25.00x28, 30-ply aircraft tires inflated to 50 psi with wheel spacing 58.5 and 29.5 in. c-c for lanes 28 and 29, respectively. Tire-print data and pertinent tire characteristics are given in figure 17.

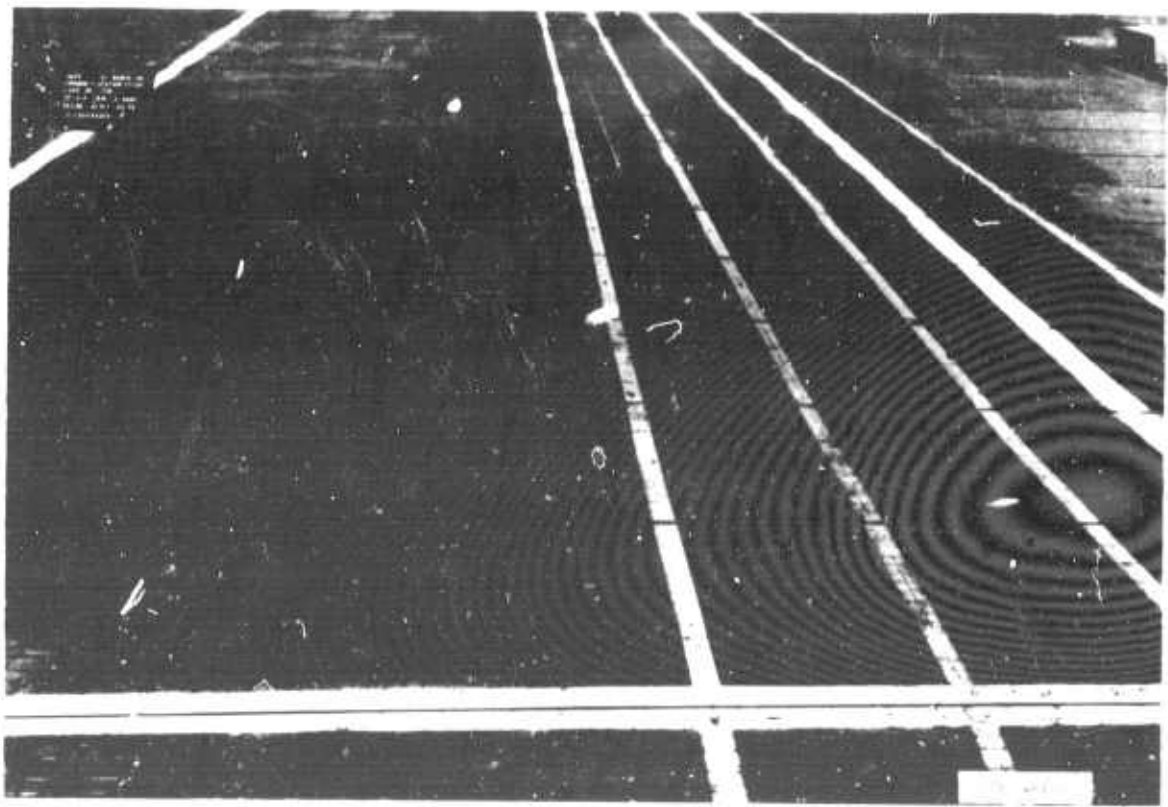
Figure 3. Lane 28, item 1, prior to traffic

Item 1. Figure 3 shows item 1 prior to traffic. At 550 coverages traffic was temporarily halted because the tires were rubbing the saddle of the load cart. At this point all pertinent data were gathered including CBR determinations. The tires were respaced to 56 in. c-c and traffic continued. Item 1 was considered failed at 700 coverages due to elastic deflection (figure 4). The rated CBR was 2.1.

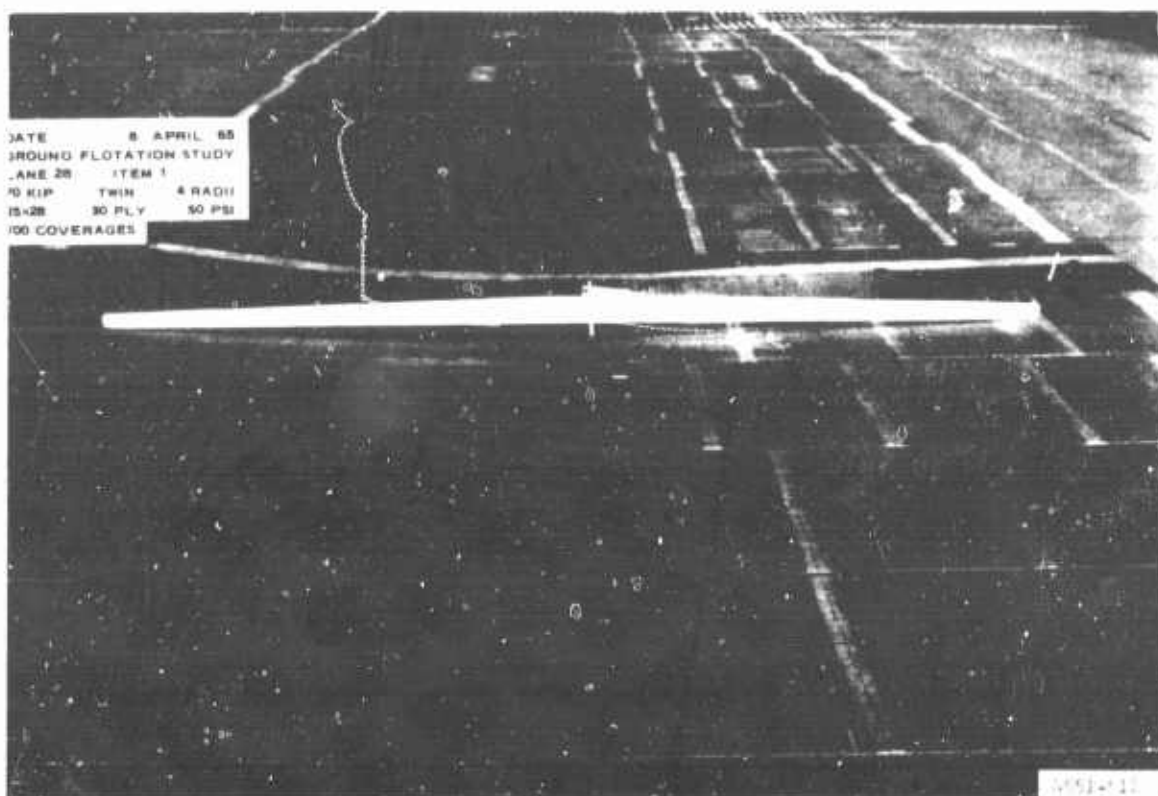
Figure 4. Lane 28, item 1, after 700 coverages of traffic (failure)

The item was considered failed due to elastic deflection at 700 coverages. The rated CBR was 2.1.

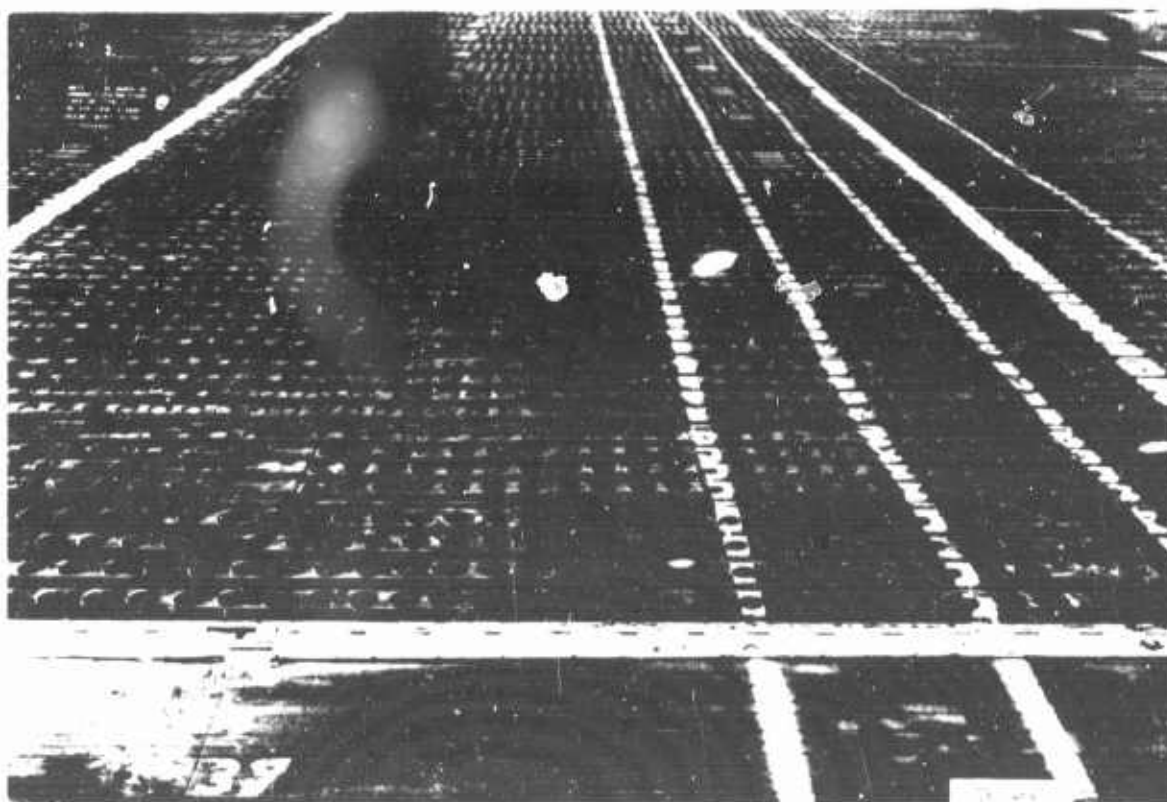
Figure 5. Lane 28, item 2, prior to traffic

Item 2. Figure 5 shows item 2 prior to traffic. The item held up well under traffic with relatively few mat breaks and deformation which developed slowly. Item 2 was considered failed at 700 coverages due to roughness (figure 6). The rated CBR was 2.8.

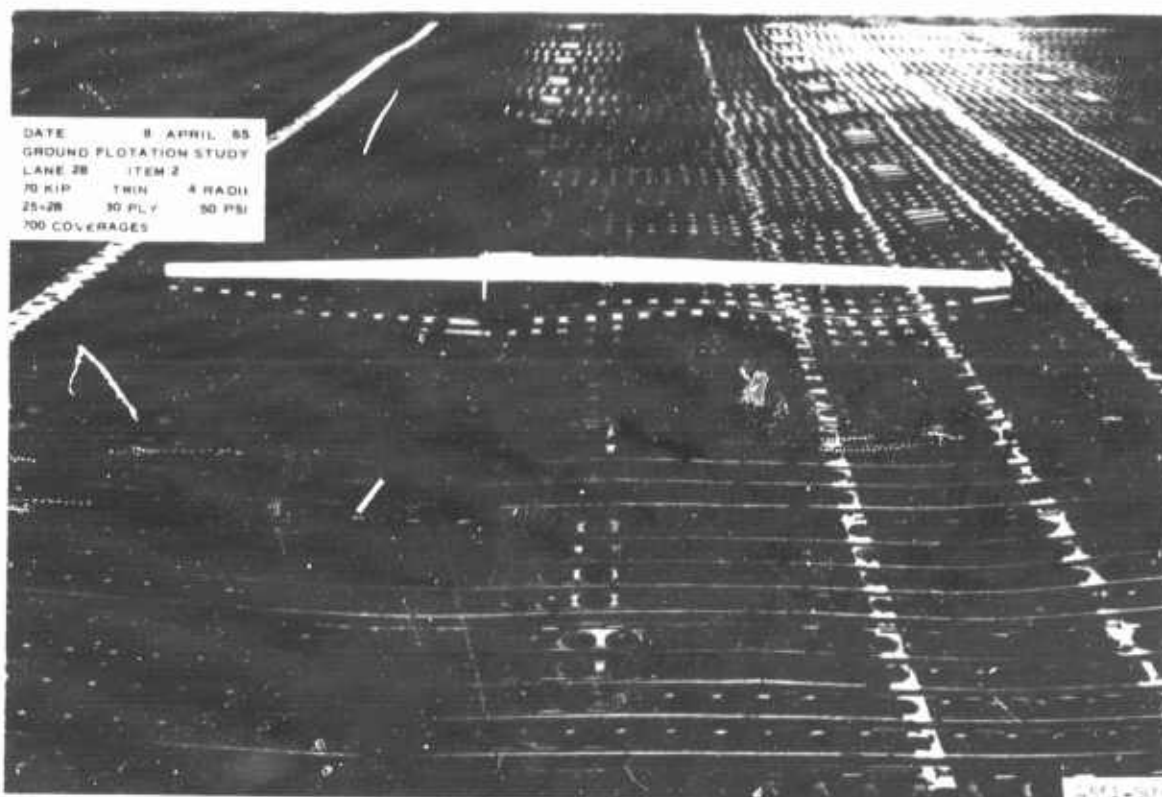
Figure 6. Lane 28, item 2, after 700 coverages of traffic (failure)

The item was considered failed due to roughness at 700 coverages. The rated CBR was 2.8.

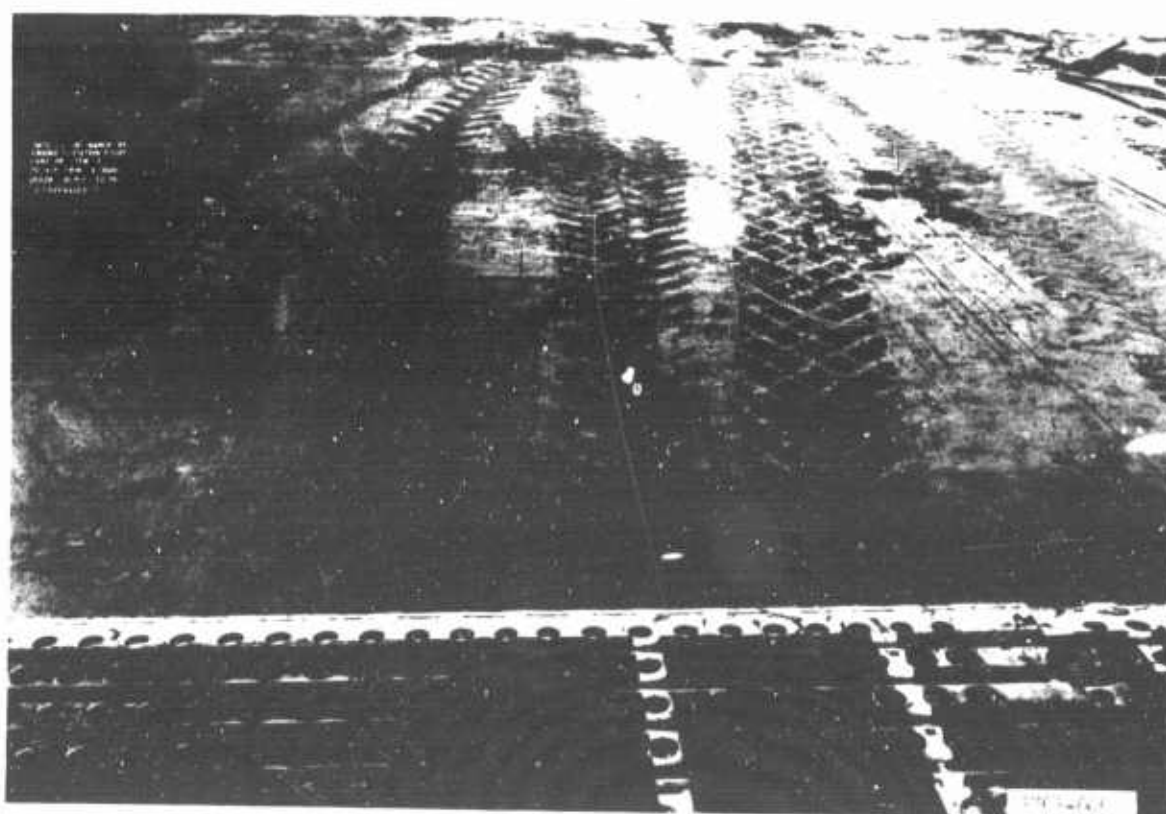
Figure 7. Lane 28, item 3, prior to traffic

Item 3. Figure 7 shows item 3 prior to traffic. Considerable subgrade settlement occurred as trafficking progressed but differential deformations and rutting were slow in developing. The item was considered failed at 200 coverages (figure 8). At failure average transverse and diagonal differential deformations considerably exceeded rutting. The rated CBR of the item was 4.7.

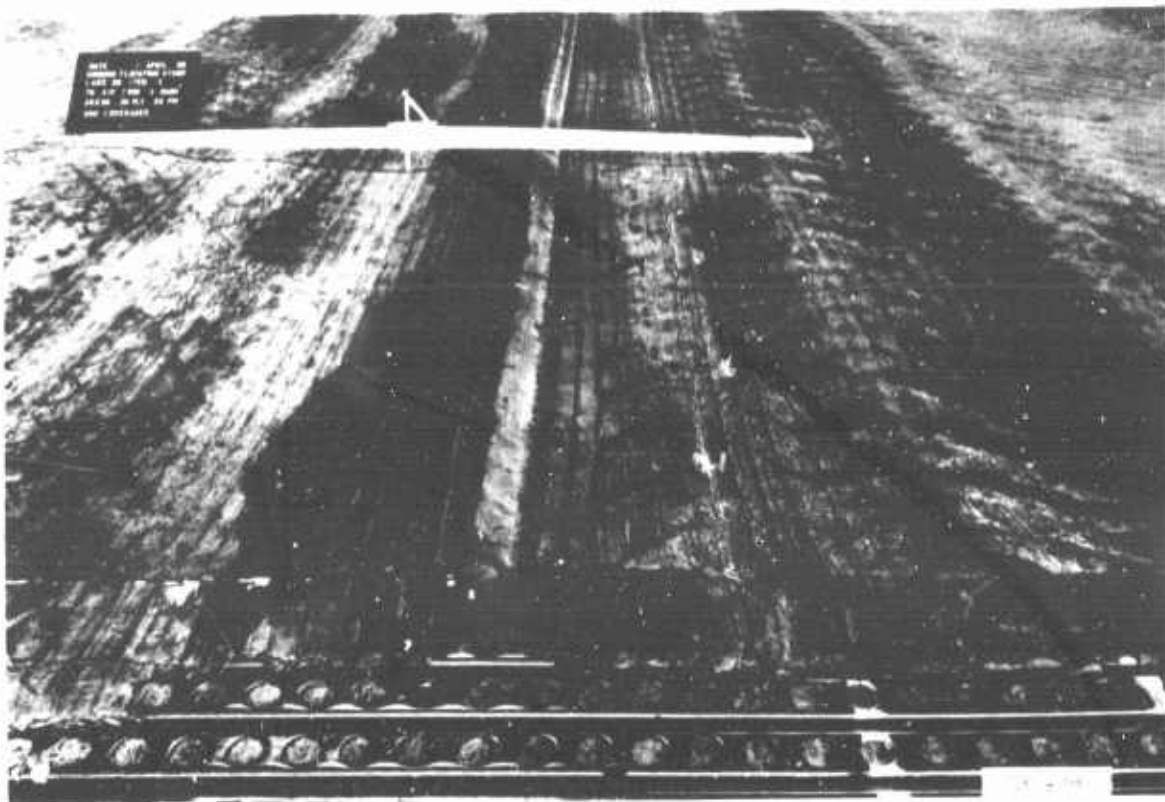
Figure 8. Lane 28, item 3, after 200 coverages of traffic (failure)

The item was considered failed due to roughness at 200 coverages.
The rated CBR was 4.7.

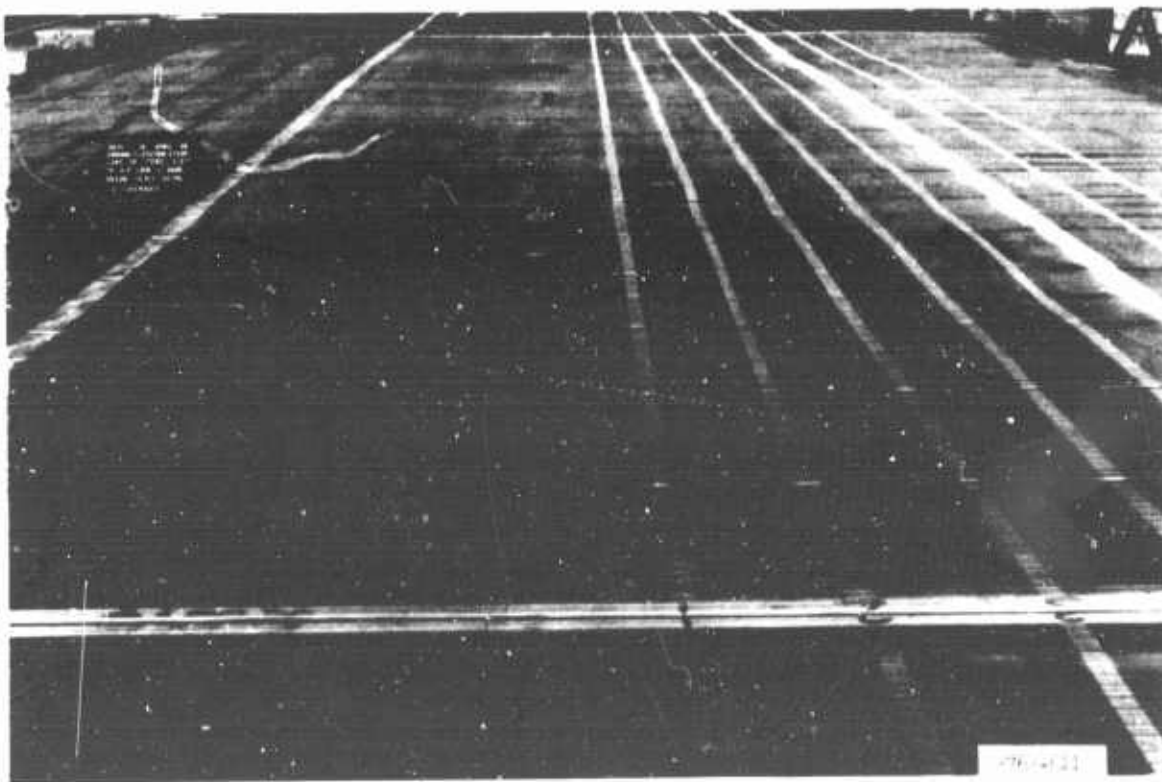
Figure 9. Lane 29, item 1, prior to traffic

Item 1. Item 1 prior to traffic is shown in figure 9. The item was considered failed at 140 coverages due to roughness (figure 10). As trafficking continued, the subgrade was laterally displaced from the lane center line resulting in subgrade subsidence and consequent mat standoff, or bridging, of approximately 2.5 in. with noticeable effect on measured deformation and deflection. The rated CBR was 1.8.

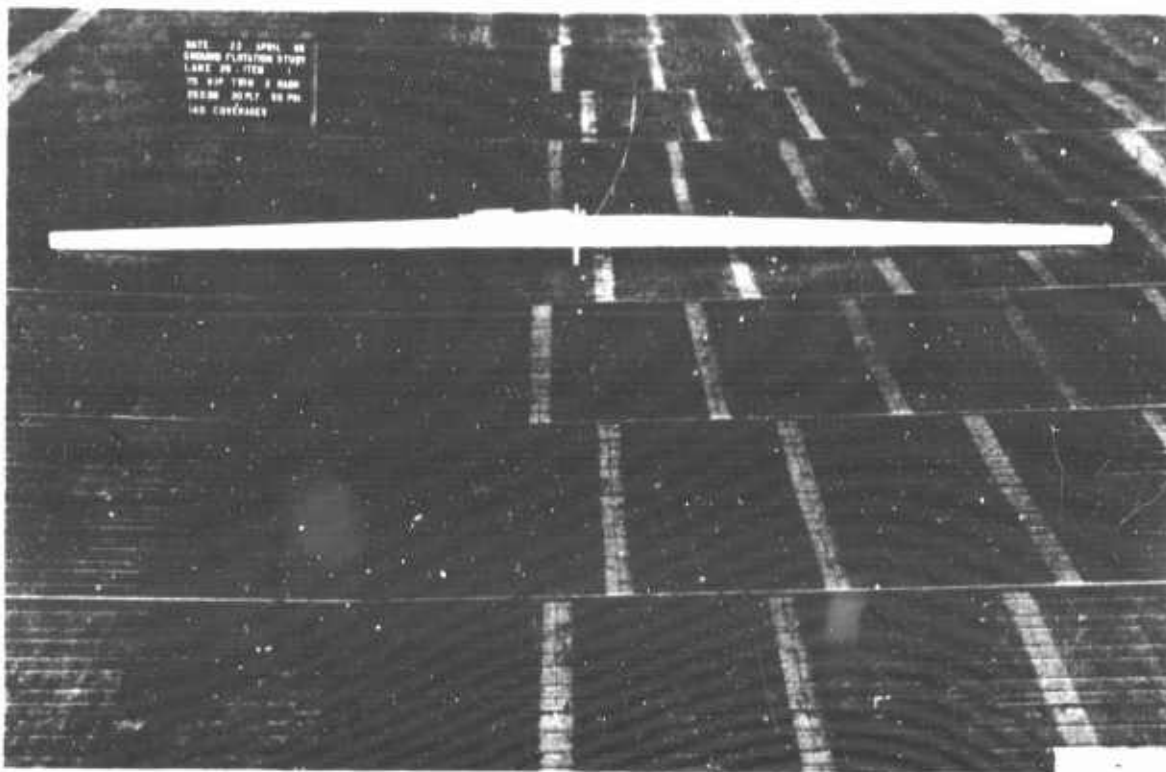
Figure 10. Lane 29, item 1, after 140 coverages of traffic (failure)

The item was considered failed due to roughness at 140 coverages.
The rated CBR was 1.8.

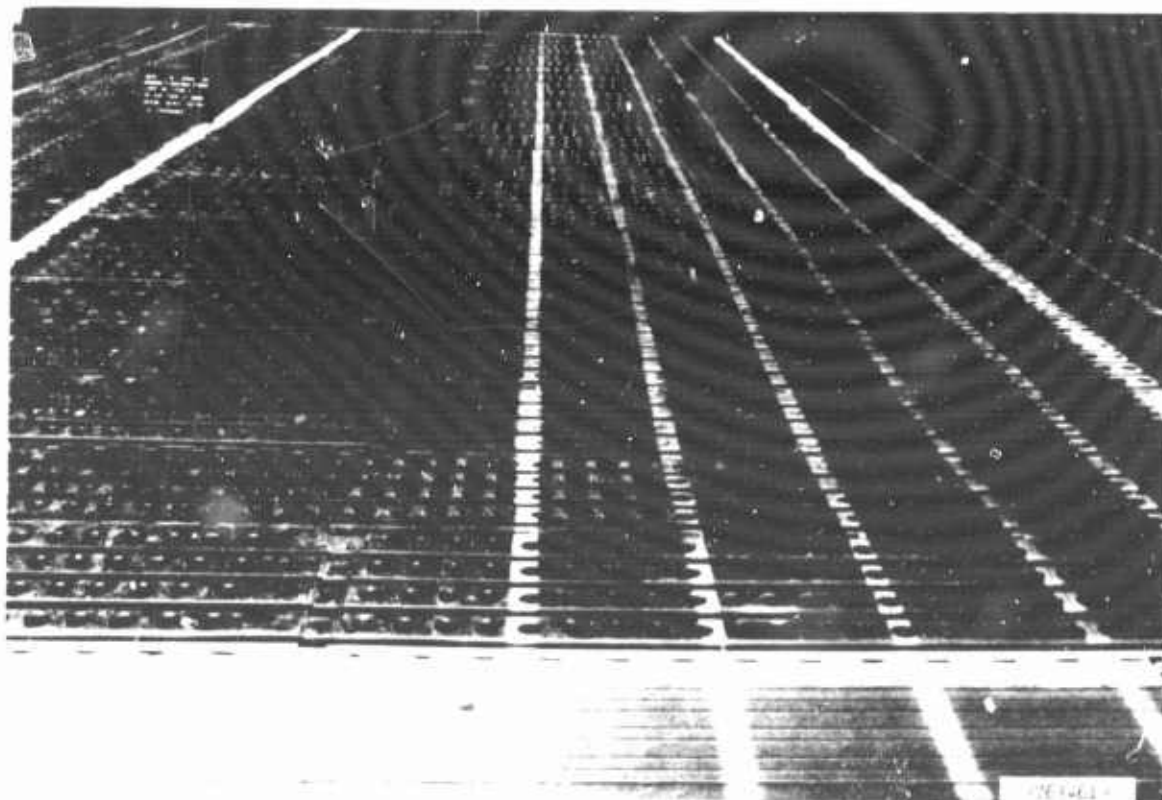
Figure 11. Lane 29, item 2, prior to traffic

Item 2. Item 2 prior to traffic is shown in figure 11. The item was considered failed at 200 coverages due to roughness (figure 12). The rated CBR was 2.8.

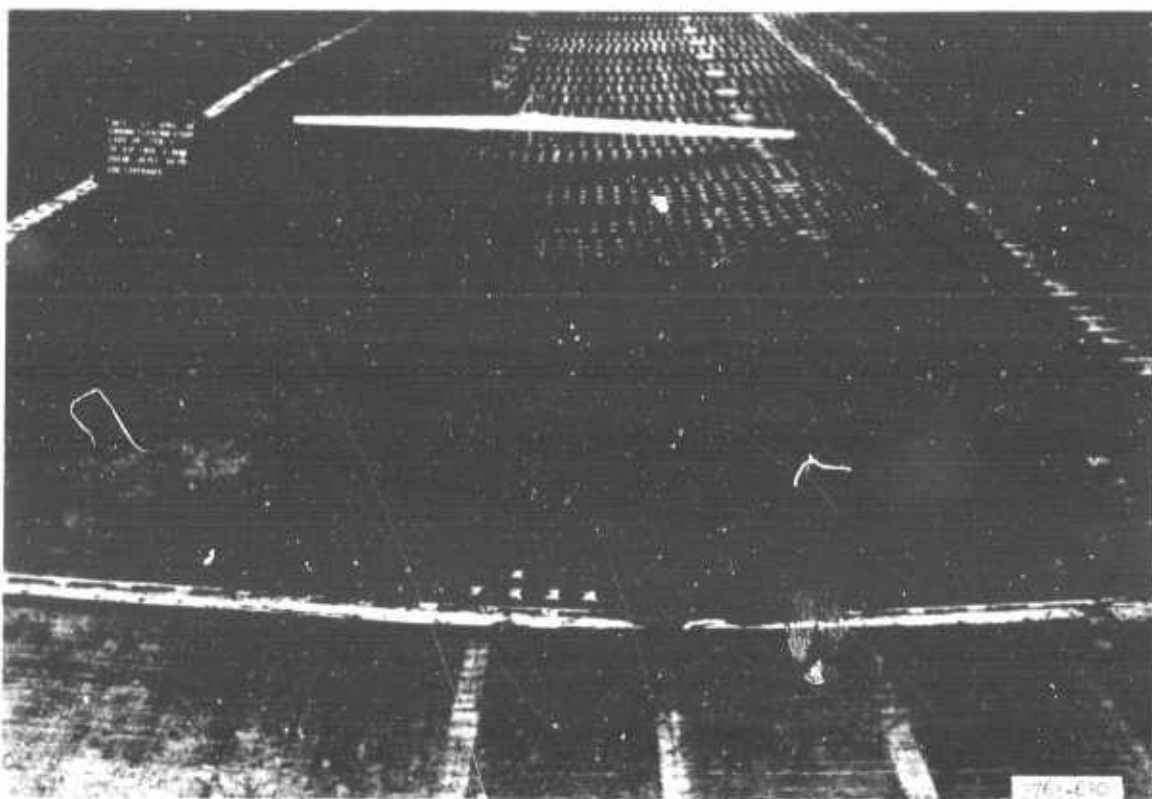
Figure 12. Lane 29, item 2, after 200 coverages of traffic (failure)

The item was considered failed due to roughness at 200 coverages.
The rated CBR was 2.8.

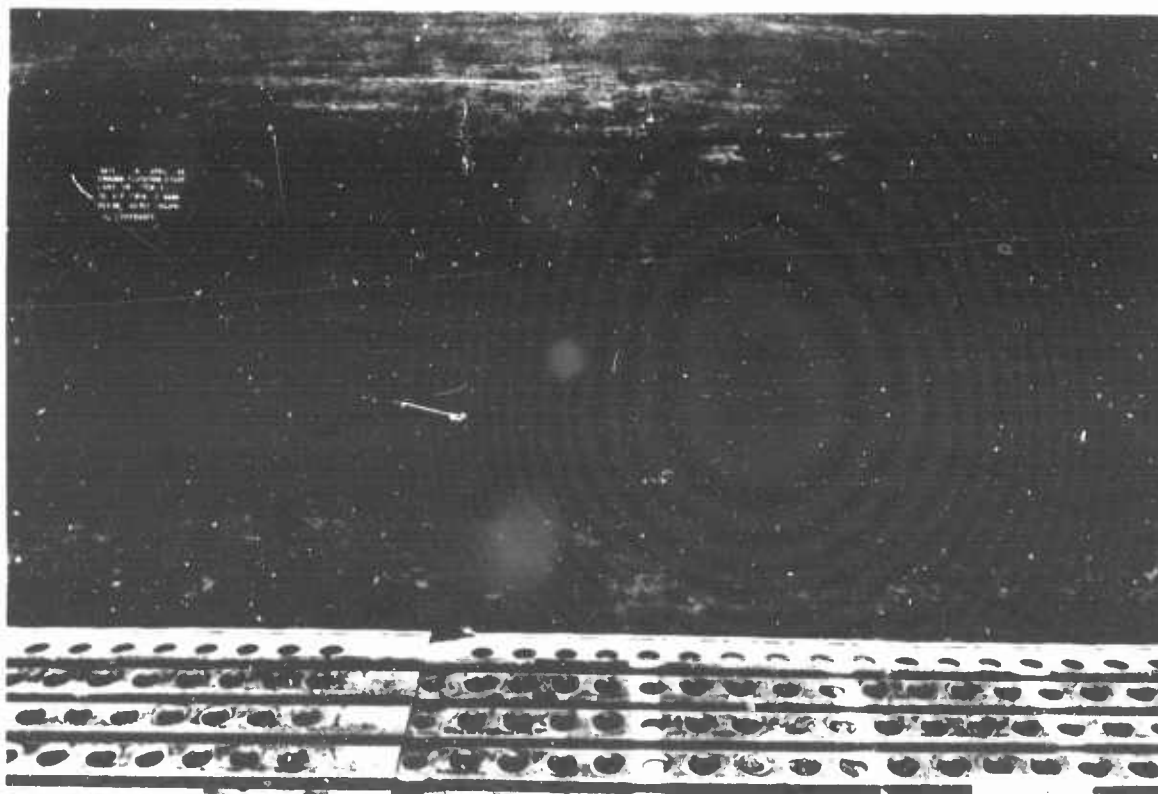
Figure 13. Lane 29, item 3, prior to traffic

Item 3. Item 3 prior to traffic is shown in figure 13. The item was considered failed at 200 coverages due to roughness (figure 14). The rated CBR was 4.5.

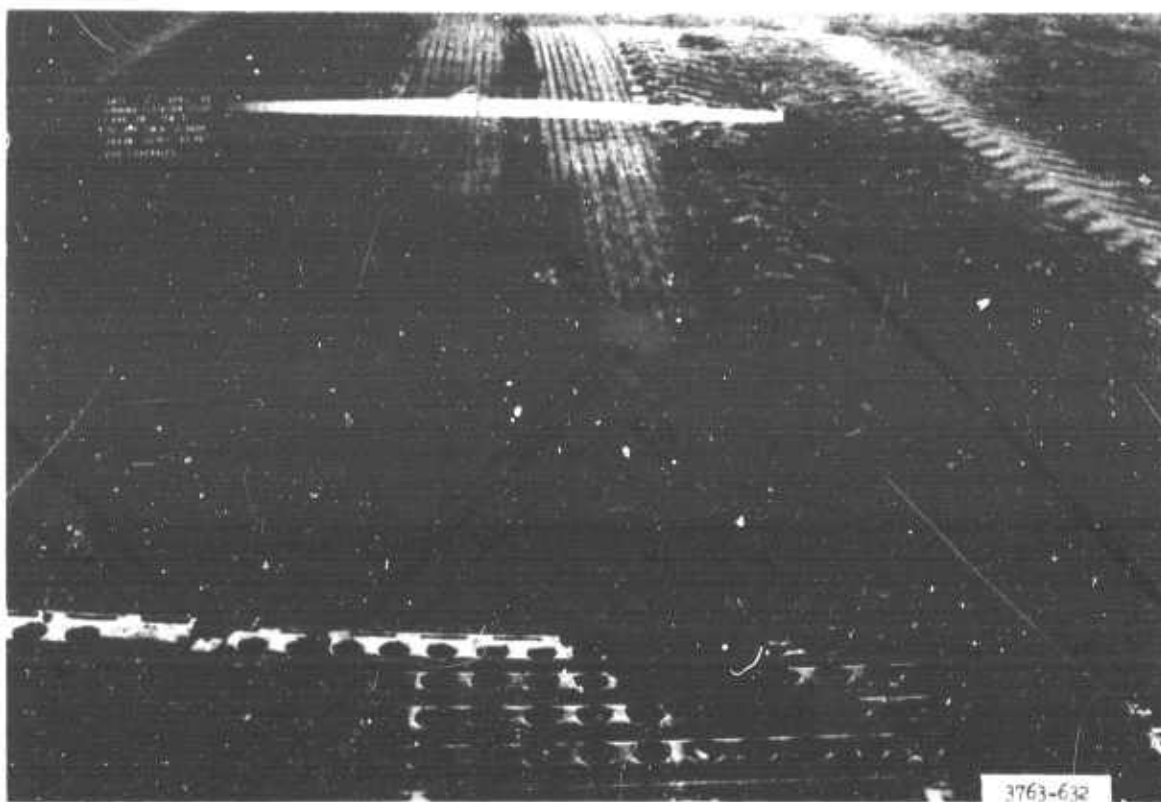
Figure 14. Lane 29, item 3, after 200 coverages
of traffic (failure)

The item was considered failed due to roughness at 200 coverages.
The rated CBR was 4.5.

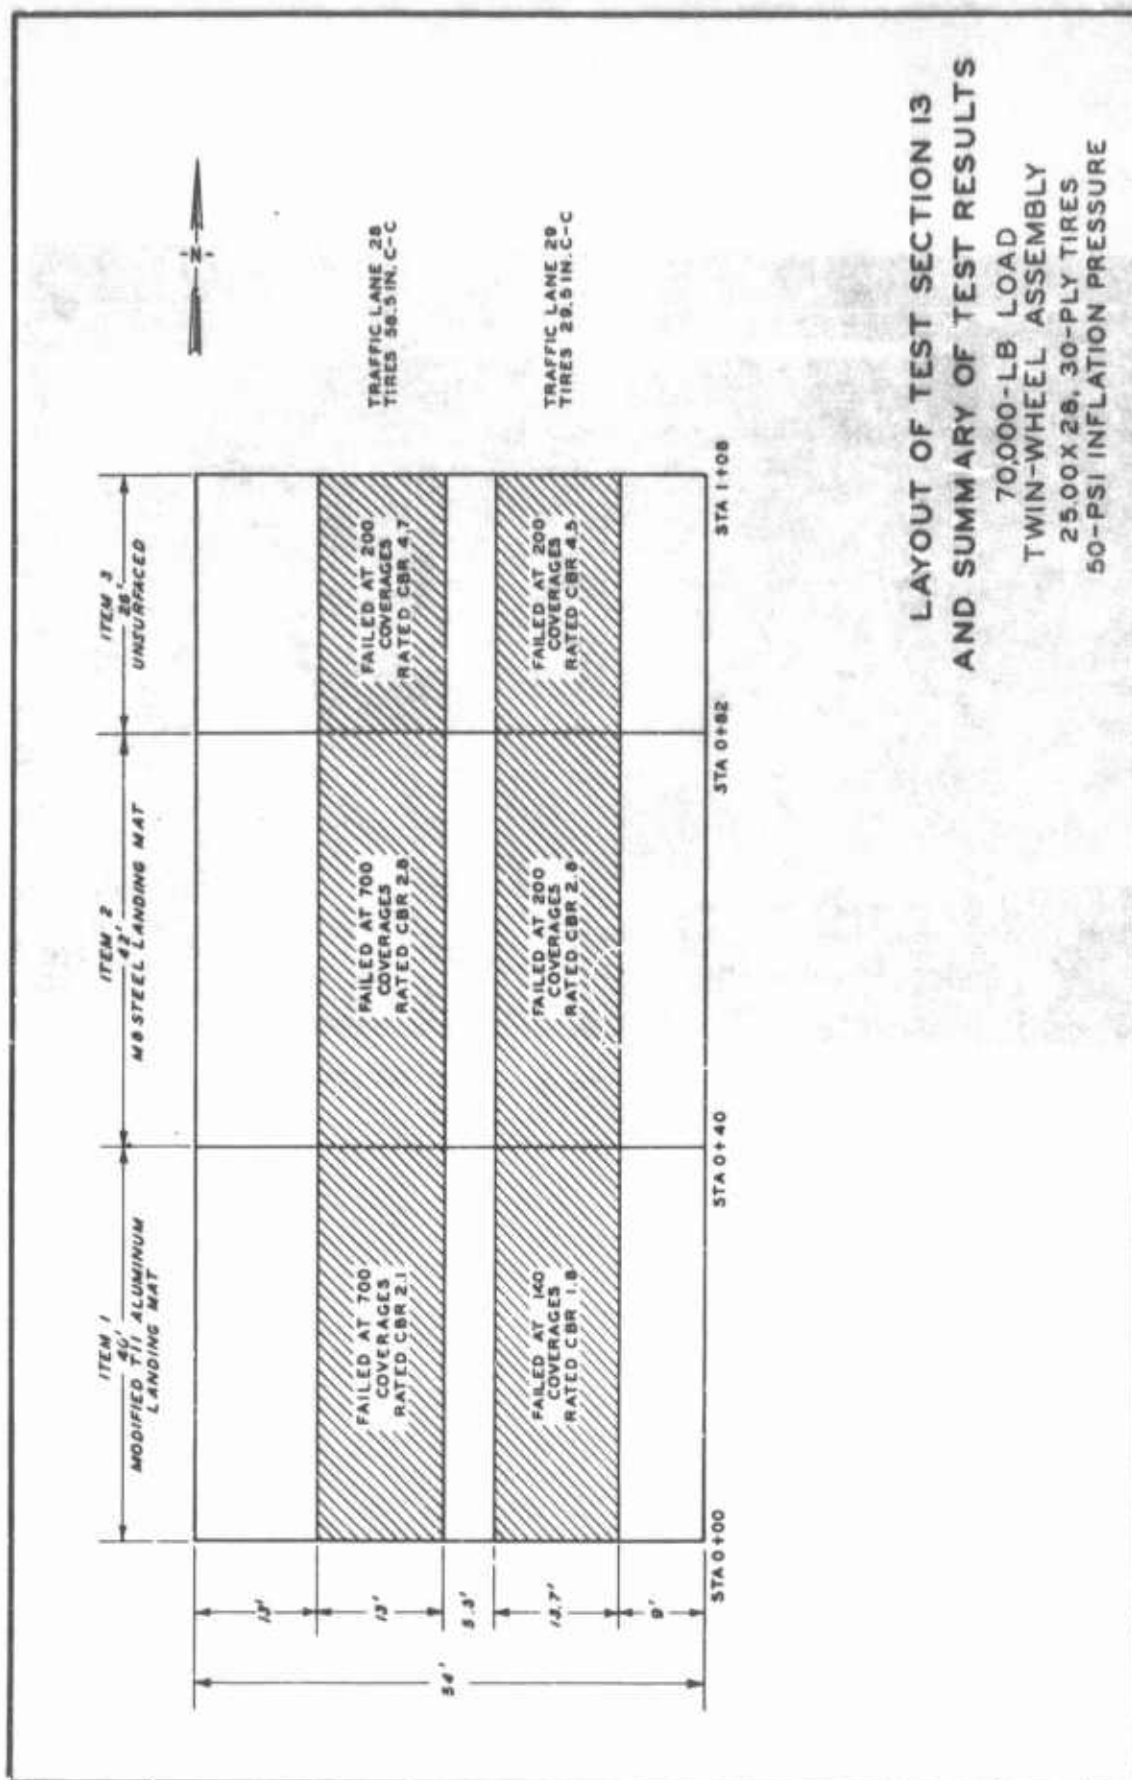
Test Section 13 (figure 15) was constructed within a roofed area in order to allow control of the subgrade CBR (California Bearing Ratio) in the test items. Section 13 was located on the same site as prior Test Sections 1, 3, and 5 in this series, the original construction of which is described in Part II of this report. The underlying subgrade was undisturbed by prior tests on the site so that in construction of Section 13 only the upper 24 in. of soil was excavated. The excavated area was back-filled to the original grade level in four compacted lifts with a heavy clay soil (buckshot; classified as CH according to the Unified Soil Classification System, MIL-STD-619). The fill material used was a local clay with a plastic limit of 27, liquid limit of 58, and plasticity index of 31. Gradation and classification data for the subgrade material are given in Part I.

Two traffic lanes, each divided into three items, were constructed in the test section. Different subgrade strengths were obtained in the items (figure 15) by controlling the water content and compaction effort. Items 1 and 2 were surfaced with modified T11 aluminum landing mat and M8 steel landing mat, respectively (figure 16), and item 3 remained unsurfaced. The landing mats used are described and illustrated in Part I.

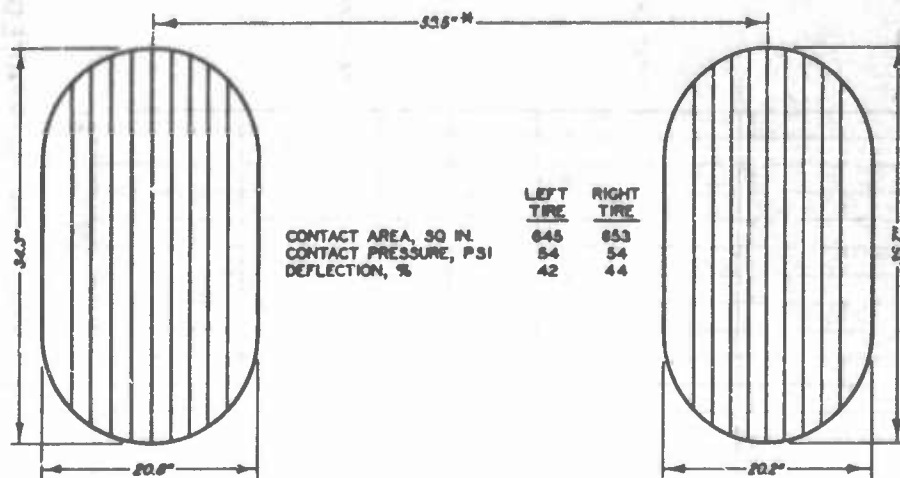
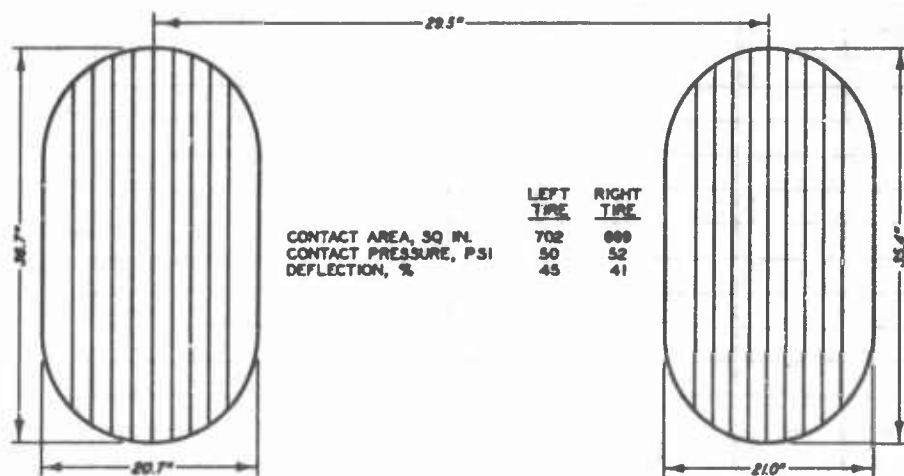
Figure 17

NOTE: * SPACING CHANGED TO 58" AT 550 COVERAGES.

TIRE-PRINT DIMENSIONS AND TIRE CHARACTERISTICS

25.00 X 28, 30-PLY TIRES
50-PSI INFLATION PRESSURE
70-KIP LOAD

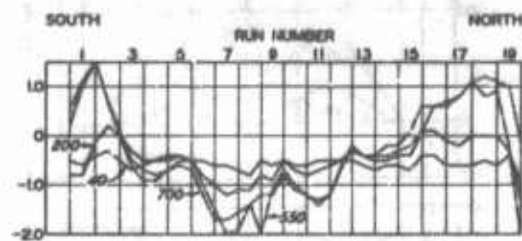
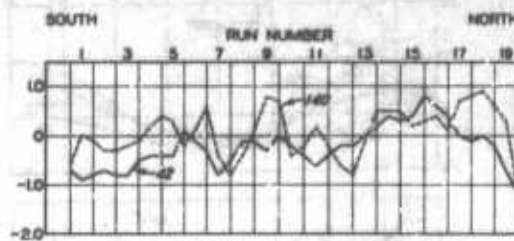
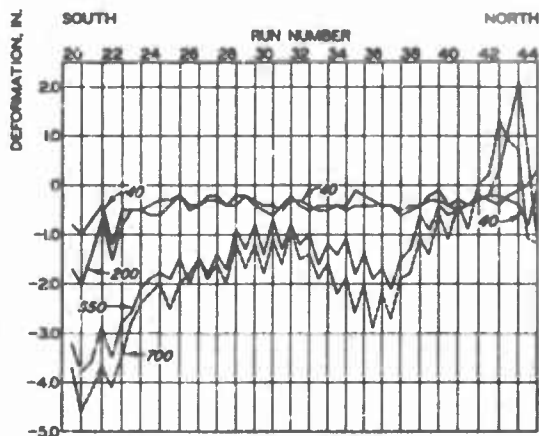
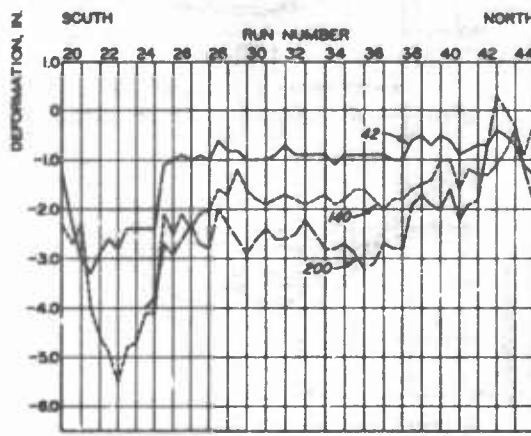
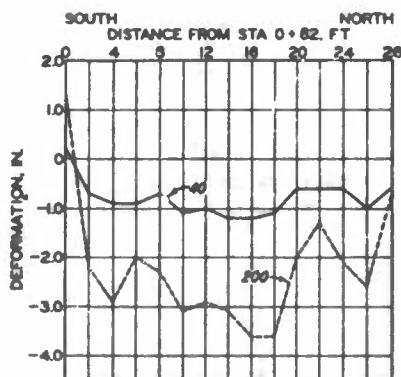
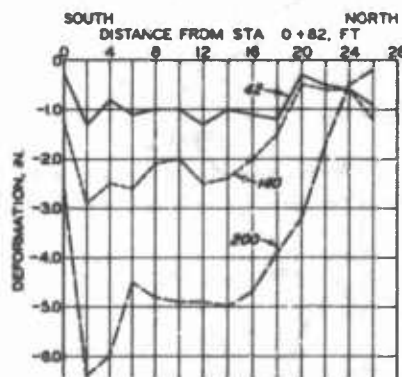
PERMANENT PROFILE
DEFORMATIONS
TEST SECTION 13
LANES 28 AND 29

- b. Deformation. Average cross-section deformations are shown in figure 18. The maximum average cross-section deformation at failure was 2.35 in. approximately 2 ft either side of the traffic lane center line. Profiles in figure 19 indicate the severe longitudinal deformations that existed in the item at failure, especially at the end adjacent to item 1.

coverages are shown in figure 18. Considerable rutting developed between the two coverage levels. Figure 19 shows profiles for 40 and 200 coverages and illustrates the progressive subsidence of the item with traffic.

shown in figures 18 and 19, respectively. The maximum average cross-section deformation was +1.9 in. and occurred along the west side of the lane. This positive deformation was due to lateral displacement of the subgrade under traffic. Figure 19 shows deformations at 42 and 140 coverages. Displacement and subsidence of the subgrade under traffic caused bridging of the mat surface and consequently a number of positive deformation readings were recorded at 140 coverages.

- b. Deformation. Average cross-section deformations for 42, 140, and 200 coverages are shown in figure 18. Deformations became increasingly severe with traffic, reaching 4.0 in. at failure. Figure 19 shows profile deformations for the same coverage levels, illustrating the very large increase that occurred between 140 and 200 coverages, especially on the end adjacent to mat-surfaced item 2.

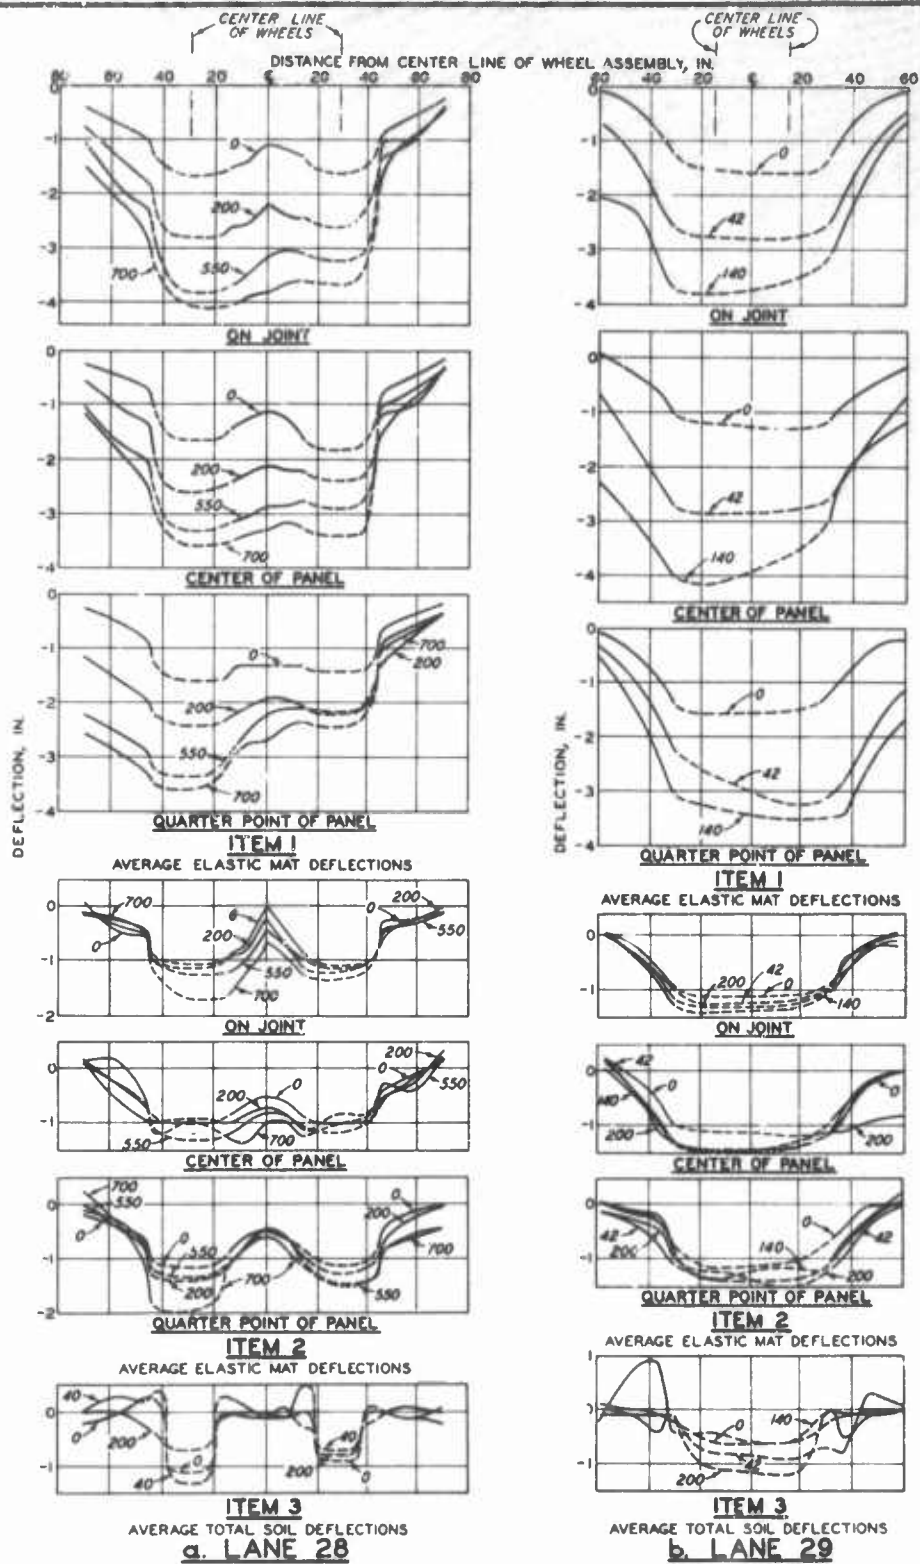
- c. Deflections. Average elastic mat deflections shown in figure 20 increased generally with traffic. The largest average deflection (4.10 in.) was recorded with the load wheels centered on a panel end joint at the 700-coverage level. At the same coverage level, the elastic subgrade deflection was 1.1 in. Elastic mat deflections were greatly exaggerated by the mat standoff, or bridging effect resulting from settlement of the subgrade with traffic.
- d. Rolling resistance. Table 1 shows drawbar pull values at several coverages. Initial, peak, and rolling drawbar pull values showed consistent increases with continued traffic.
- e. Mat breaks. The number and types of mat breaks are given in table 1. Relatively few mat breaks occurred with most of these being rivet failures.

- c. Deflection. Average elastic mat deflections are shown in figure 20. Table 1 shows elastic subgrade deflections beneath a load wheel for several coverage levels. Elastic subgrade deflection at failure was 0.70 in.

- c. Deflection. Total subgrade deflections are shown in figure 20 for 0, 40, and 200 coverages. Maximum deflection occurred at 40 coverages. Elastic subgrade deflections shown in table 1 decreased with traffic.
- d. Rolling resistance. Consistent increases in initial, peak, and rolling drawbar pull were measured as coverage levels increased (table 1).

- c. Deflections. Deflections shown in figure 20 increased consistently with traffic. The large deflection measurements were due to the mat standoff effect resulting from subsidence of the subgrade. Elastic subgrade deflection at failure was 2.2 in. (table 1).
- d. Rolling resistance. Initial, peak, and rolling drawbar pull values at several coverage levels are shown in table 1. Rolling and peak drawbar pull increased consistently with traffic, while initial drawbar pull decreased slightly at 140 coverages.
- e. Mat breaks. Number of breaks by type are shown in table 1. There were a large number of rivet failures at 140 coverages.

- c. Deflection. Average elastic mat deflections for three positions of the wheel assembly relative to mat joints are plotted in figure 20. Deflections did not vary greatly at the different coverage levels shown. Elastic subgrade deflection at failure was 1.50 in. (table 1).

- c. Deflection. Total subgrade deflections shown in figure 20 somewhat erratic at intermediate coverage levels but yielded greatest values at failure. Table 1 shows elastic subgrade deflections with a value of 0.65 in. at failure.
